Bypassing separated files in the apical third: A case series using the same technique

ABSTRACT

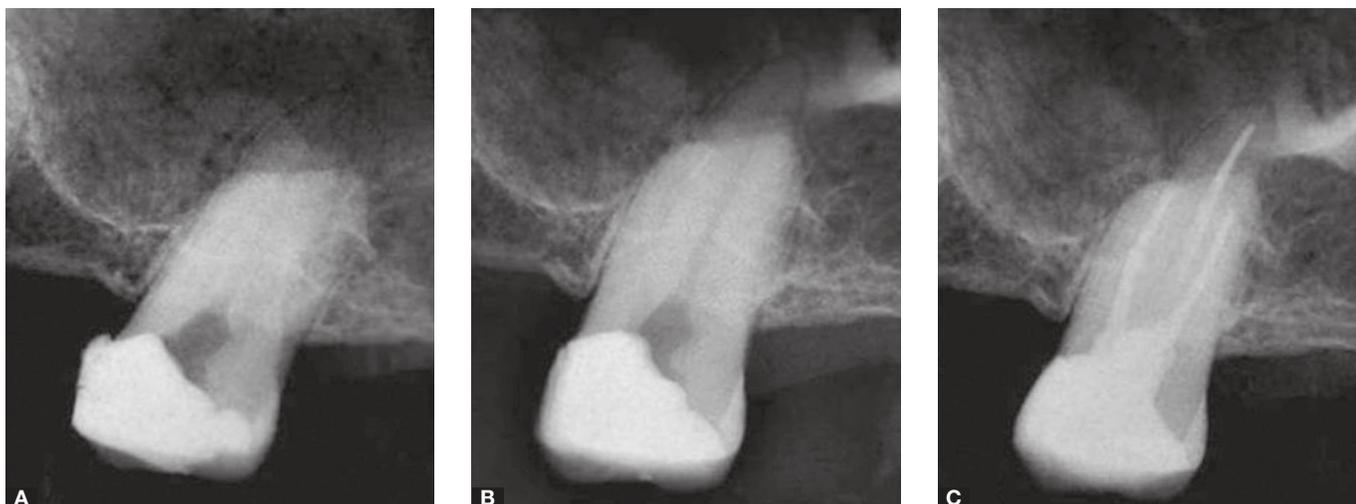
Figure 1. **A)** Initial radiograph; **B)** Fractured file in the mesiobuccal canal; **C)** Final radiograph.

A 37-year-old caucasian male patient was referred for endodontic treatment of tooth #27 after an episode of irreversible pulpitis and emergency intervention (Fig 1A).

Orange County, USA). During this process, in the mesiobuccal (MB) canal, a 15 K-FlexoFile (Dentsply/Maillefer, Ballaigues, Switzerland) was fractured. This occurrence was confirmed radiographically (Fig 1B). Instrumentation of DB and P canals was performed following the principles of the crown-down technique using 2.5 ml of 2.5% sodium hypochlorite (Fórmula & Açã, São Paulo, Brazil) at each change of files up to files 35 and 40/04 (Dentsply/Maillefer, Ballaigues, Switzerland), respectively.

With the aim of bypassing the fractured instrument, a 15 K-File (Dentsply/Maillefer, Ballaigues, Switzerland) had its tip cut in an angle of approximately 45 degrees so as to make it active. Subsequently, a chelating solution of 17% EDTA (Fórmula & Açã, São Paulo, Brazil) was applied to the canal and maintained there for about three minutes. From this point on, a pre-curved sectioned instrument was introduced up to the cervical segment of the fractured file and introduced laterally by means of longitudinal and rotational movements. After the process of bypassing, the working length was determined and instrumentation was performed as described above.

In the following visit, after nerve block with 4% articaine and epinephrine 1:100.000 (Articaine – DFL Indústria e Comércio Ltda., Rio de Janeiro, Brazil), rubber dam positioning and cleaning of the operative field with 2.5% sodium hypochlorite (Fórmula & Açã, São Paulo, Brazil), the temporary restoration was removed with 1016 HL spherical burs (KG Sorensen, Barueri, Brazil), followed by removal of the partial filling from the palatal canal using Gates Glidden drills (Dentsply/Maillefer, Ballaigues, Switzerland), fiber glass post proof (Fiberpost - Angelus, Londrina, Brazil), cementation with resin cement – Rely X (3M Brazil Ltda., Sumaré, Brazil) and definitive restoration with Z250 composite resin (3M Brazil Ltda., Sumaré, Brazil) (Fig 1C).

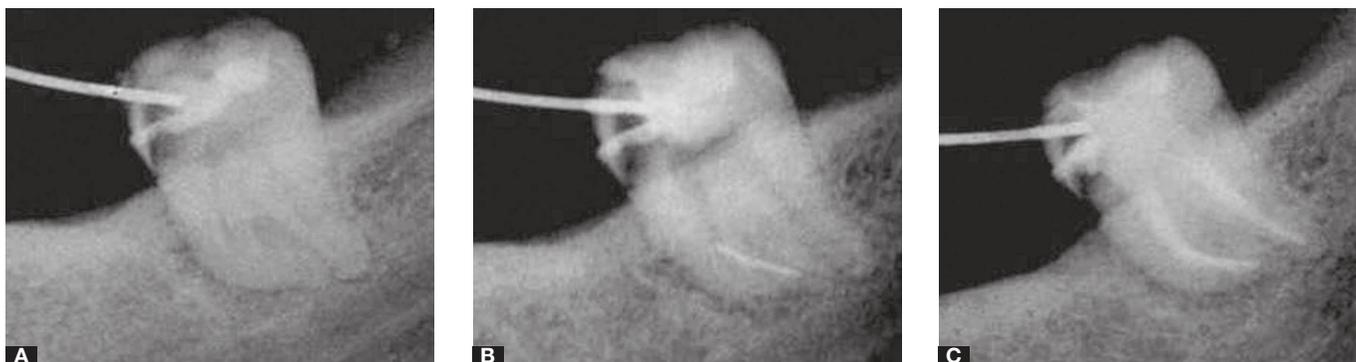
Figure 3. A) Initial radiograph; B) Fractured instrument in the mesial canal; C) Final radiograph.

A 49-year-old caucasian female patient was referred for endodontic treatment of tooth #38 for prosthetic purposes. Clinical analysis revealed the presence of an adhesive prosthesis using the referred tooth as one of the pillars. Initial radiograph showed considerable infiltration and severe curvature in the mesial root (Fig 3A).

In the following visit, with the aim of bypassing the separated instrument, a 10 K-File had its tip cut in an angle of approximately 45 degrees so as to make it active. Subsequently, a chelating solution of 17% EDTA (Fórmula & Ação, São Paulo, Brazil) was applied to the canal and maintained there for about three minutes. From this point on, a pre-curved sectioned instrument was introduced up to the cervical segment of the fractured instrument and introduced laterally by means of longitudinal and rotational movements.

After bypassing, the working length was determined and instrumentation was performed as described above up to 35/04 file (Profile System – Dentsply/Maillefer, Ballaigues, Switzerland).
